HONDA INSTALLATION INSTRUCTIONS

FRONT GRILLE P/N 08F21-T7S-100 Application

2016 HR-V

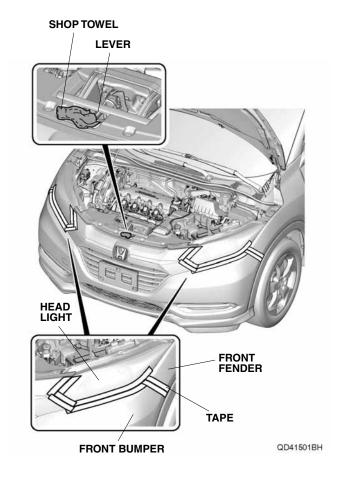
- 1. Disconnect the negative cable from the battery.
- 2. Remove the front bumper:
 - Wrap a shop towel around the lever.
 - Attach tape to the areas shown on each side.

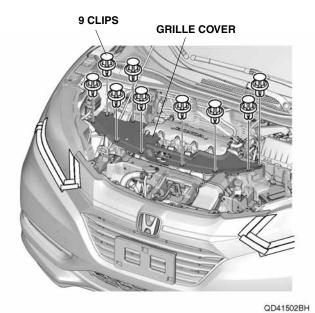
Remove the grille cover.

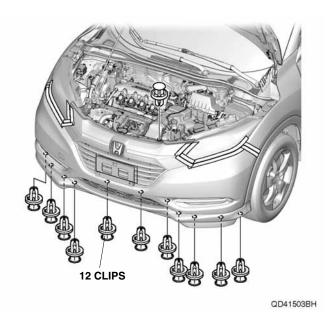
Remove the 12 clips.

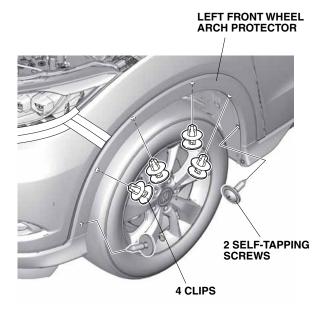
Remove four clips and two self-tapping screws on each side.

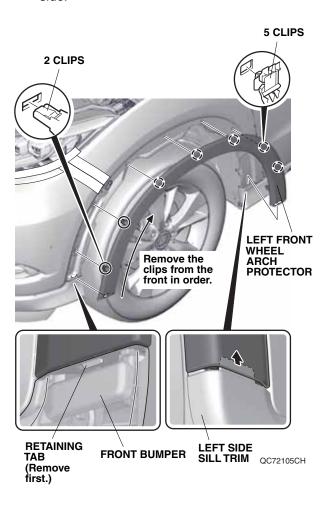
Remove the front wheel arch protector on each side.

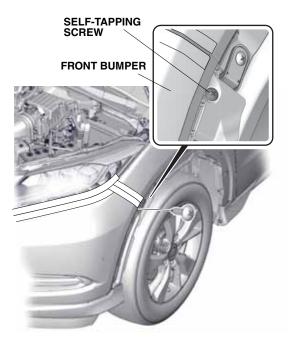
• Remove the self-tapping screw on each side.

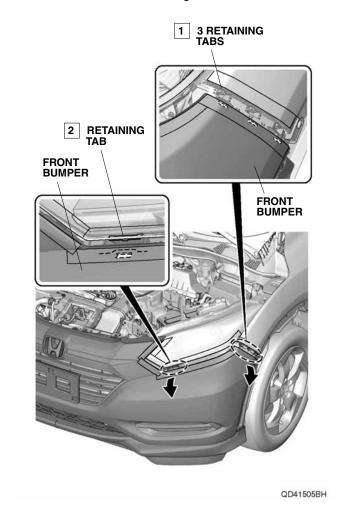
• Release four retaining tabs on each side.

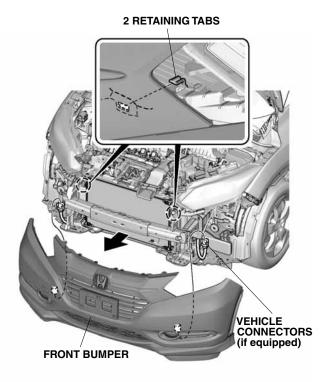
With the help of an assistant, remove the front bumper and unplug the vehicle connectors, if equipped. Place the front bumper on the blanket to prevent damage.

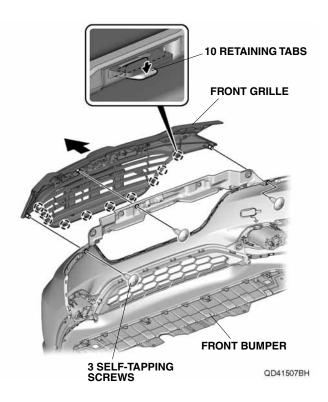
3. Remove the front grille from the front bumper.

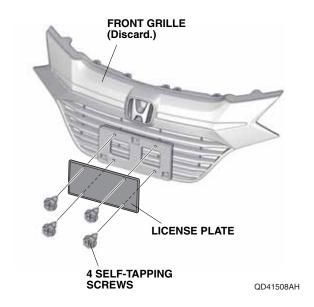
4. Remove the license plate.

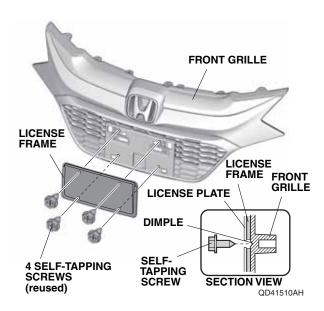
6. Attach the license frame to the front grille.

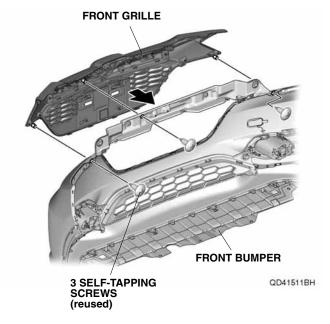
7. Install the front grille on the front bumper.
